**North Slope of Alaska ARM Facilities  
Monthly Status Update  
Sandia National Labs**

**October 2017**

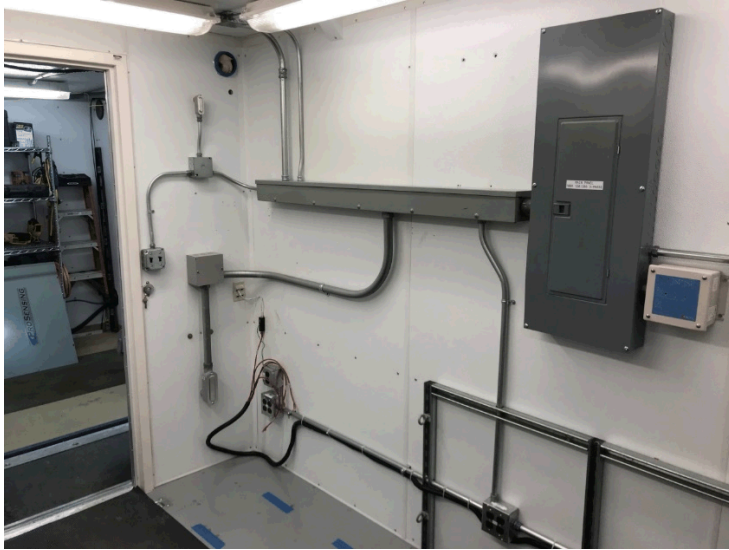
AMF3 SACRII pedestal was removed and will be stored in Deadhorse for the winter.

*SACRII Shelter with PDU and racks removed, main panel rewired.*

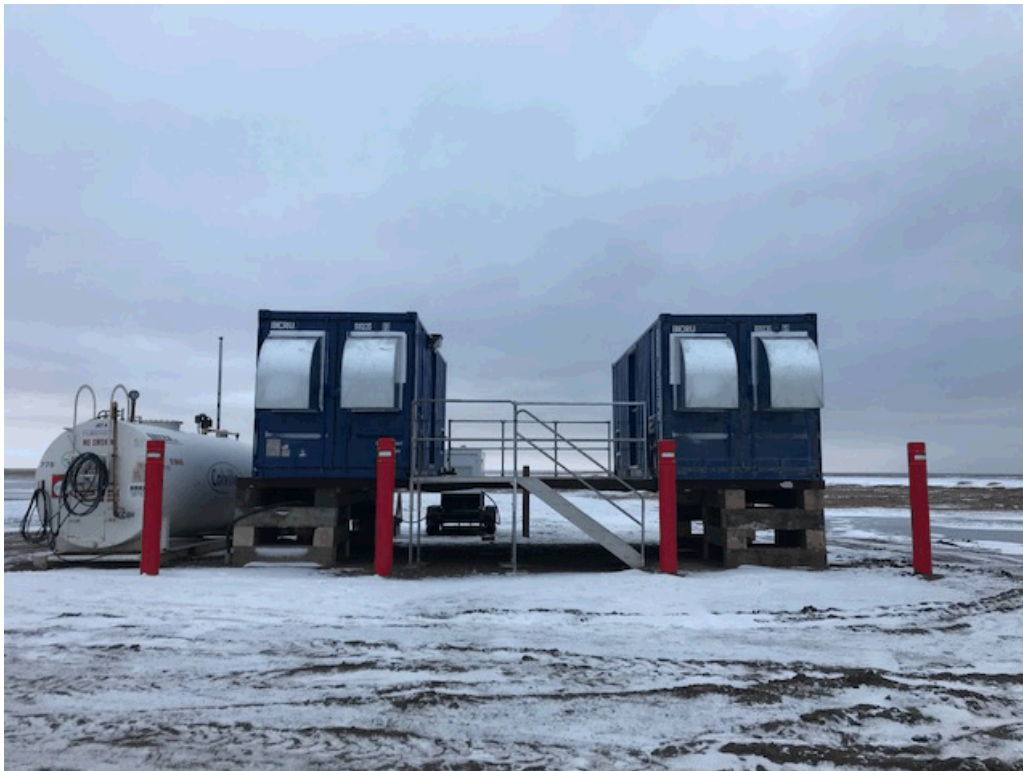
Three of the four Capstone micro-turbines were repaired and arrived at AMF3 on 10/26/2017. The micro-turbines are currently stored in the Sprung Structure pending install in power shelters.

*Power shelter upgrade*

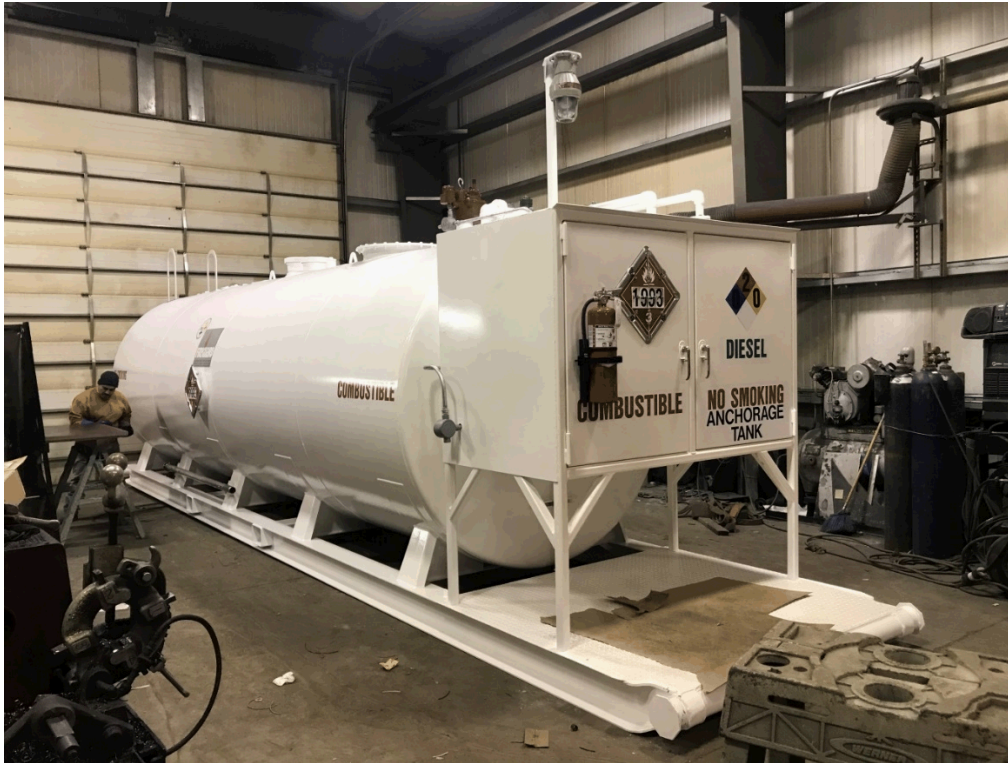
*Replacement 25,000 gallon diesel fuel tank arrived at AMF3.*

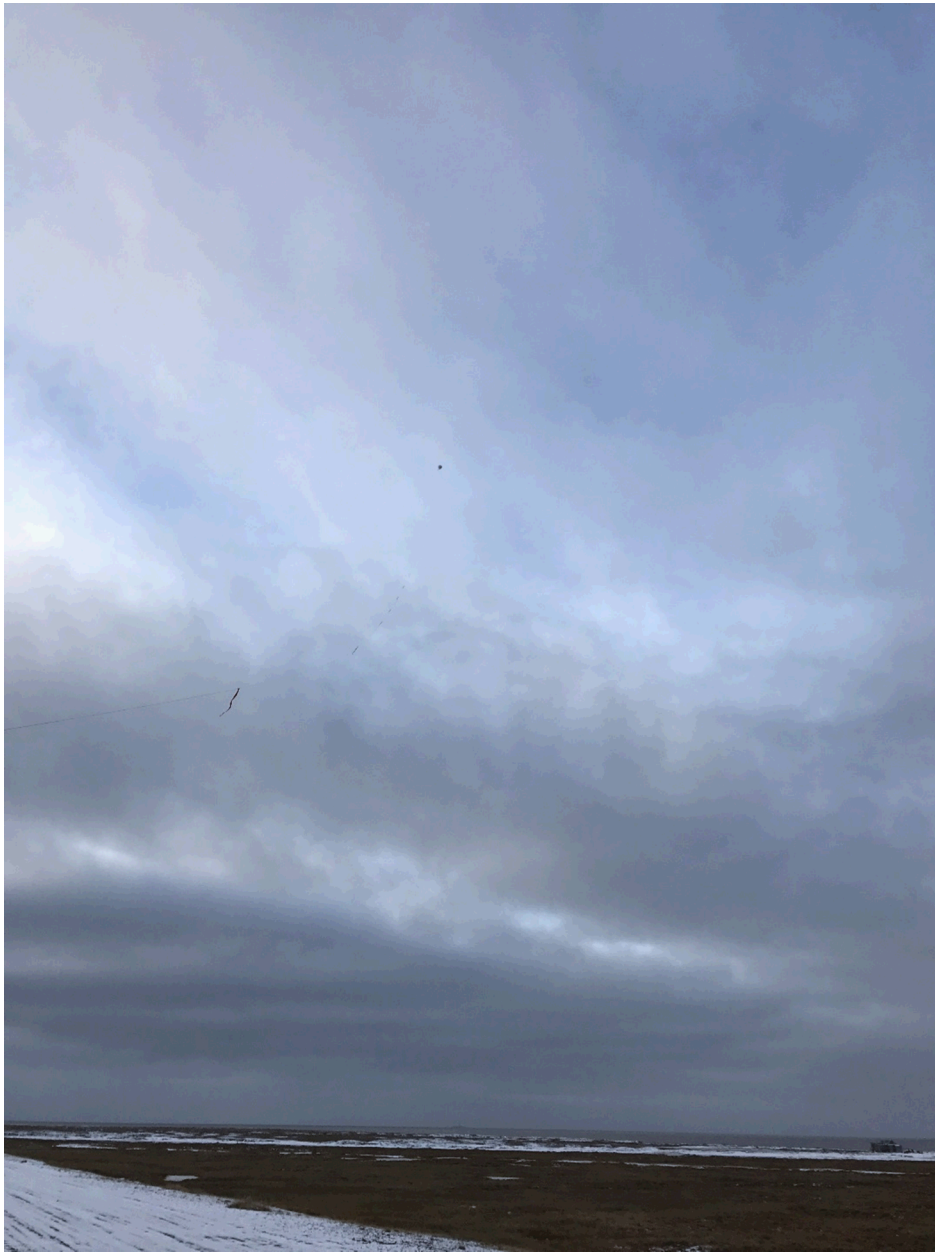
This helikite had several holes along the main seam upon inflation and was patched. After flight it had lost at least one bottle of helium, and will need to be inflated with air and patched more thoroughly before being used again.

The helikite and tether shifted significantly from being parallel with the winch when snowflakes moved in and the winds shifted to the southeast. The tether jumped off the edge of the winch fairlead rollers and was frayed by abrading against the edge of rollers. The tether was going to be replaced at the end of this campaign anyway, so we will replace it before flying again and returned for repair.

*Helikite and sky conditions at 23:06*

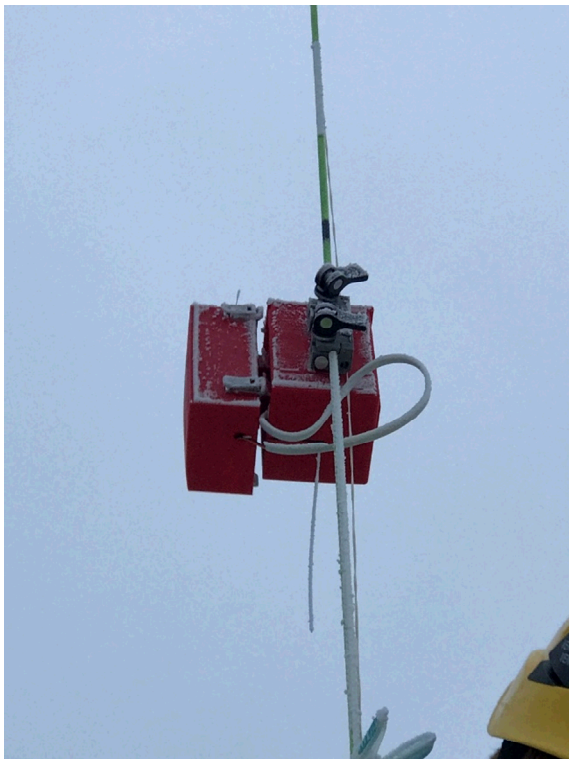
Ascended to 1.44 km at 22:55, began descent at 00:16. Static DTS Ch2 plugged in 00:20 – 00:35. Started descent 00:42, visually balloon observed out of cloud base at 01:08. Icing observed on tether starting at 560m on descent. Icing intensified significantly at 500m.

*Icing on tether, iMet, and SLWC boxes; tether is neon green*

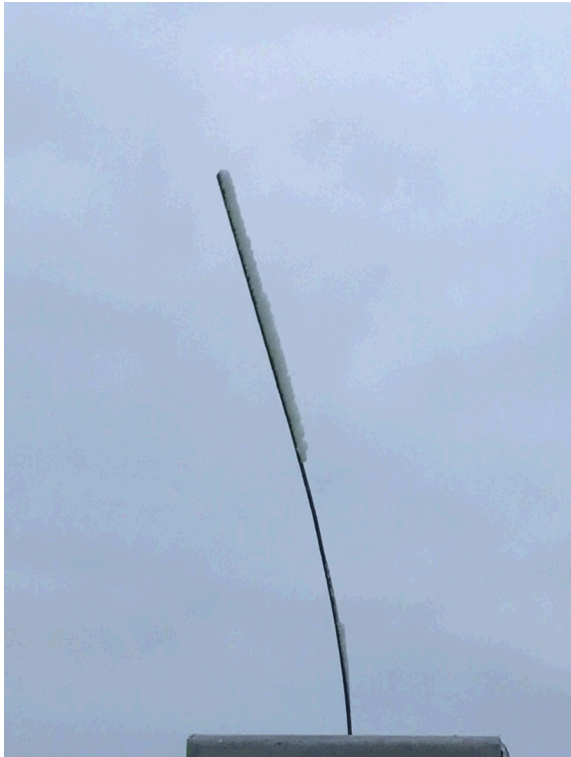
*Ice on vibrating wire of SLWC*

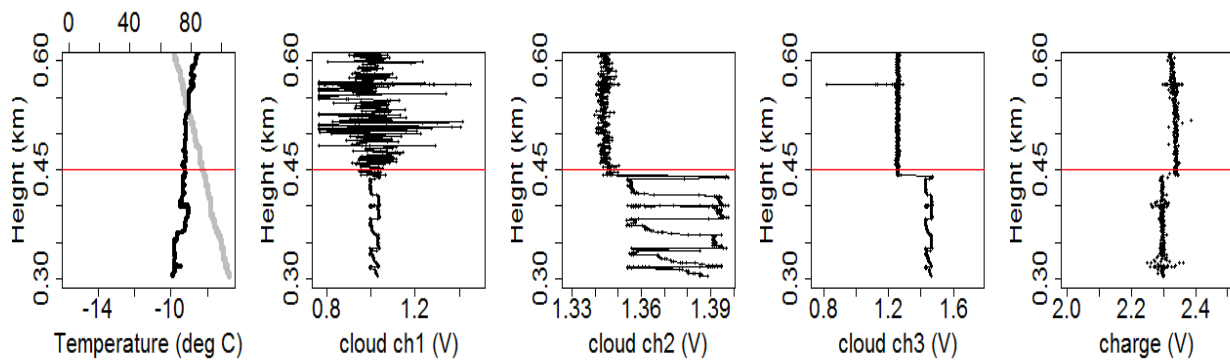
Radiosonde interference issues:

- High power mode suspected at 1007-50 mbar = 957 mbar = 450m
- Oscillations in cloud sensor below this height (in all channels). High power seems to sort out ch2, but knocks out ch1 and 3 (3 becomes unresponsive but 1 is just noisy).

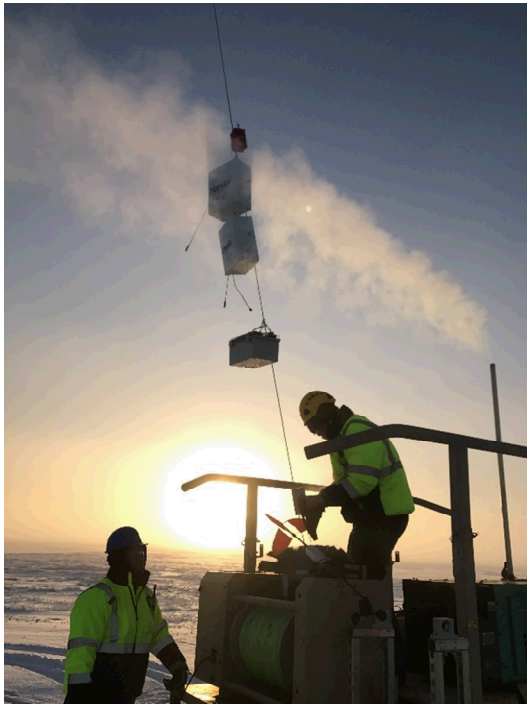
*POPS and CPC in generator plume on ascent*
